Contract #: 04-0120F4Cty: SF/ALA Rte: 80 PM: 13.2/13.9File #: 69.28**WELDING INSPECTION REPORT****Resident Engineer:**Pursell, Gary**Address:** 333 Burma Road**City:** Oakland, CA 94607**Report No:** WIR-004770**Date Inspected:** 12-Nov-2008**Project Name:** SAS Superstructure**OSM Arrival Time:** 1330**Prime Contractor:** American Bridge/Fluor Enterprises, a JV**OSM Departure Time:** 2230**Contractor:** Zhenhua Port Machinery Company, Ltd (ZPMC), Changxing Island **Location:** Shanghai, China

Bridge No: 34-0006**Component:** OBG Fabrication**Summary of Items Observed:**

OBG Bay 4

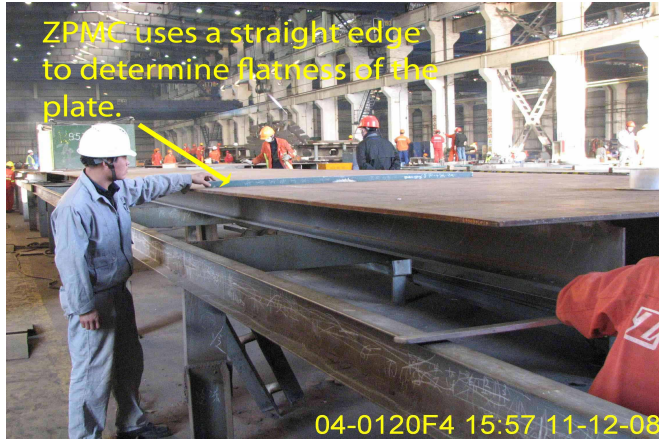
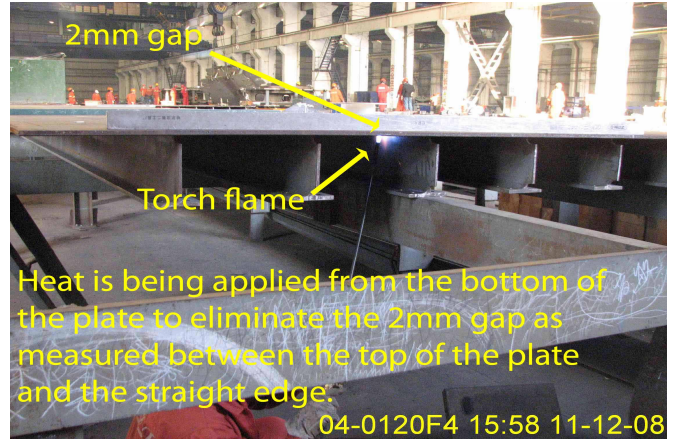
The Caltrans QA Inspector monitored ZPMC performing heat straightening of side plate SP765A in OBG Bay 4. Earlier in the day Caltrans personnel had observed this side plate was not flat. At around 1500 hours the QA Inspector observed ZPMC appears to have completed heat straightening of several sections of the side plate. The QA Inspector used a 1.5 meter long straight edge to gauge the flatness of one end of the side plate and a 2mm gap was observed under the center of the straight edge. The photograph below shows ZPMC heating the underside of the side plate to eliminate this gap. The QA Inspector observed ZPMC QC representative Mr. Huang Min was using a laser device to measure the temperatures of the areas that were being torch heated. Mr. Min showed the QA Inspector ZPMC heat straightening record #HSR1(B)-3625 dated 11-10-2008 that states SP765(A) had a maximum deformation of about 7mm, and that the plate will be heat straightened to eliminate this deformation. Below are photographs of ZPMC performing heat straightening of this side plate.
